INSPECTION REPORT

Project Name:	Mountain Valley Pipeline	Inspector:	John McCutcheon
Inspection Date:	Thursday, July 19, 2018	Project Contact:	Brian Clauto
Spread:	Spread H	Weather (Wet/Dry/Rain):	Dry

Comments: This report is for an inspection in the vicinity of the Cahas Mountain Road 2 crossing from STA 13322+00 to STA 13346+00. (Note: These stations were taken off of the E&S plan sheets and differ from the stationing noted on the stakes in the field.)

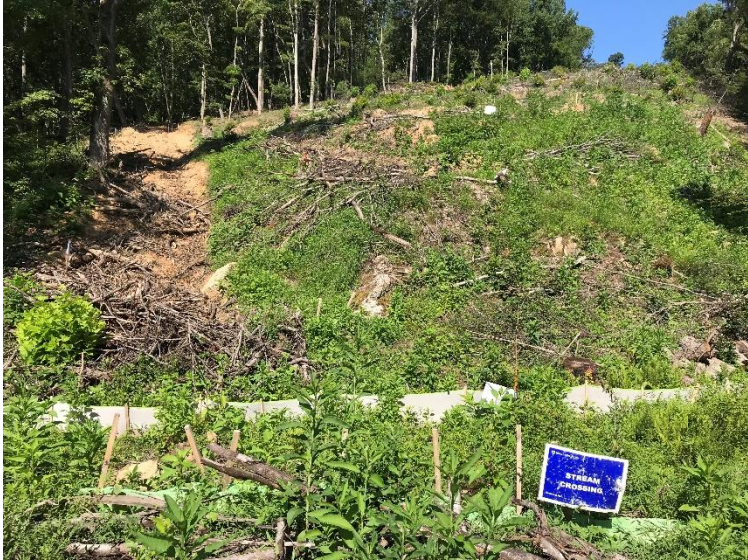
Comments 1 & 2

1. The ROW from 13322+00 to Stream Crossing S-IJ1 at STA 13334+00 appears to have been timbered prior to MVP in this area. Logging roads lead into this area from offsite and large logs have been removed. The area is poorly stabilized with low brush and small branches left behind by the timbering. Rough slope breakers have been installed across the ROW, which discharge into brush barriers, typical of timber-harvest agricultural BMPs. Bare areas are eroding and some sediment is being discharged off the ROW through the brush barriers onto undisturbed areas and is not reaching the stream below.

2. Silt fence is in place on the west side of stream at Crossing S-IJ, below the timbered slope. This silt fence is in very good condition, has no sediment build-up and appears to be effectively protecting the stream from sediment from the timbered area.

Timbered area and silt fence above stream.

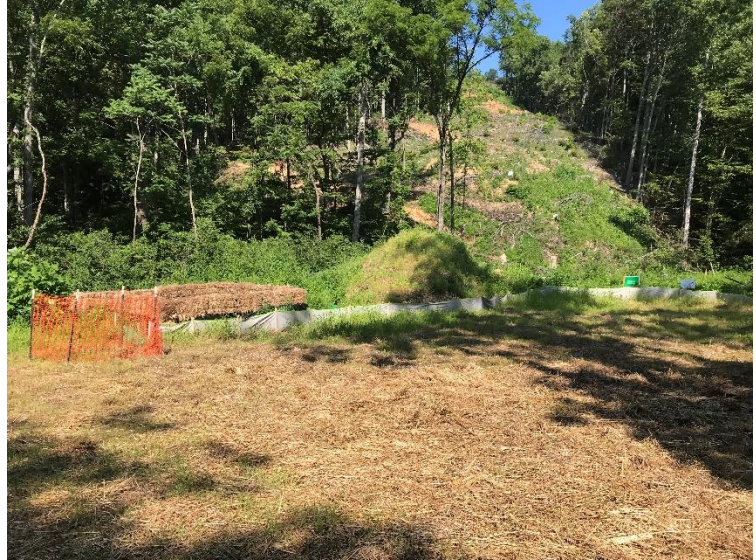
Comment 3

3. The area to the east of the stream was previously disturbed by the bore under Cahas Mountain Road. This area is well-stabilized with straw and new grass and perimeter ECDs. Silt fence is in place on the east side of the stream and is in good condition.

Stabilized area at previous bore.

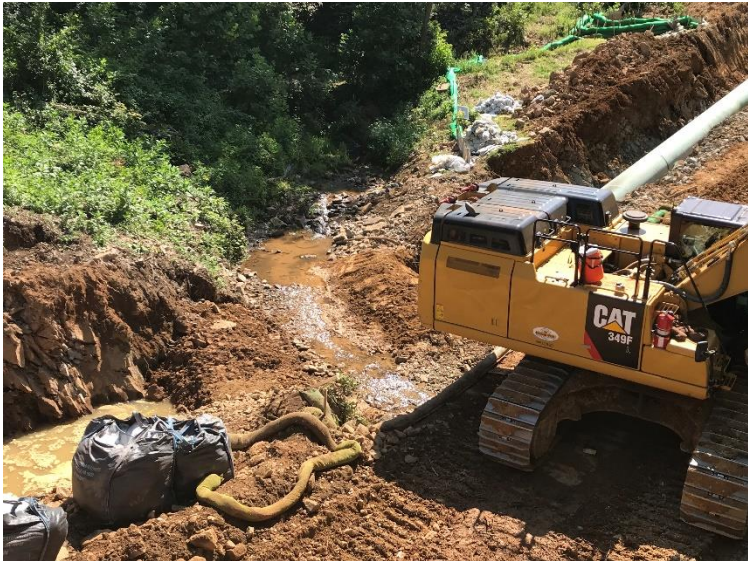
Comment 4

4. Stream Crossing S-IJ4 at STA 133346+00 was backfilled the previous night and sediment was in the steam below the crossing. Crews were shoveling sediment out of the stream bed but could not work past the ROW limits. Apparently the backfill placed over the open-cut trench was not stabilized and when the temporary dam upstream from the cut was removed, the stream flow eroded the backfill, transporting sediment off the ROW. Stabilize stream bed and banks immediately after work (backfill) is completed and before stream flow is directed over the disturbed area. (9VAC 25-840-40.15.) Continue to seek downstream landowner permission to remove remaining sediment from stream bed and remove sediment as permissible. (9VAC 25-880-70.II.G.2.)

Unstabilized stream bed at pipe crossing.

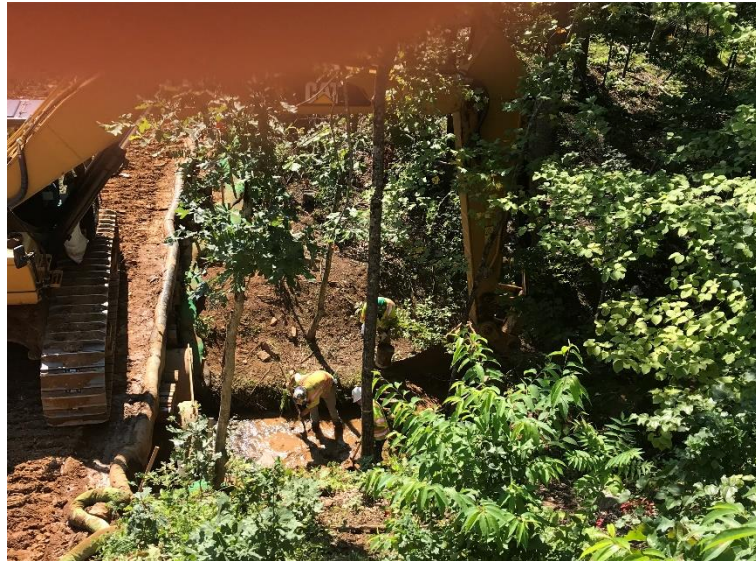
Comment 4

Sediment being removed from stream.

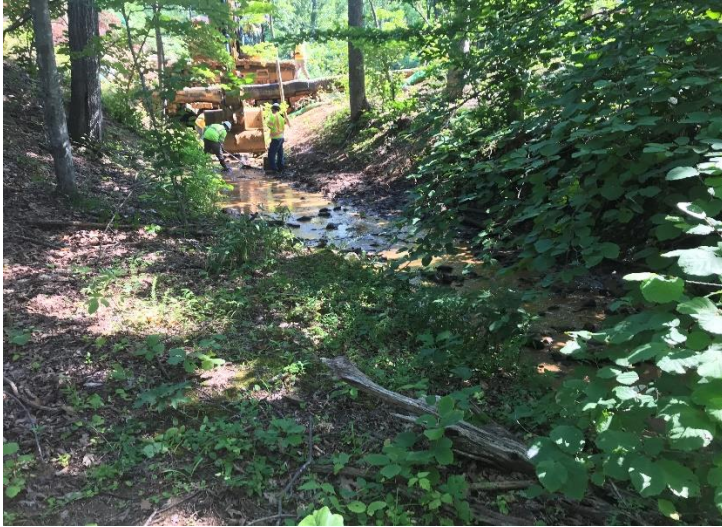
Comment 4

Sediment in stream.

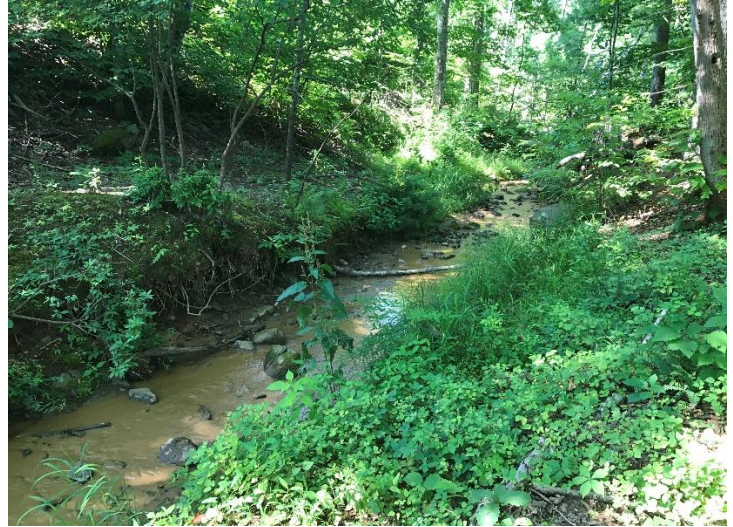
Comment 4

Sediment in stream off ROW.
